**Arborist Report**

TO: Chris Burrus - Harbour Homes LLC  
SITE: 13437 NE 100th St, Redmond, WA 98033  
DATE: February 27, 2019  
PROJECT ARBORIST: Joshua Petter  
ISA Certified Arborist #PN-8406A  
ISA Qualified Tree Risk Assessor

REFERENCED PLANS: Redmond 9 Short Plat, Source Harbour Homes LLC., Date September 20, 2018,  
Revised December 20, 2018

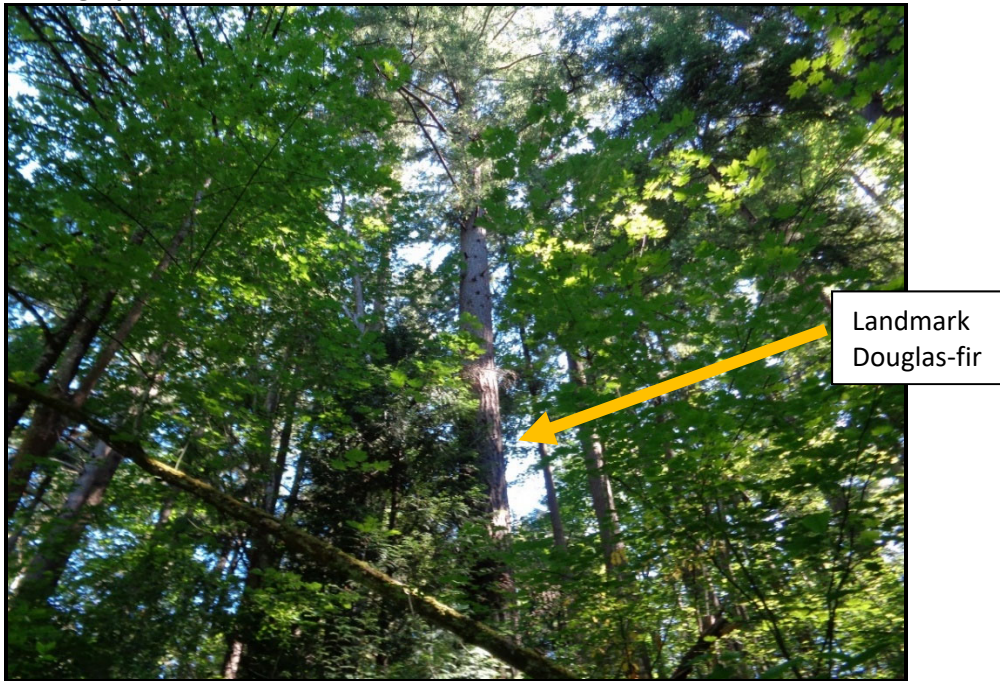
**Photo 1:** There are many large native trees adjacent to the riparian area.

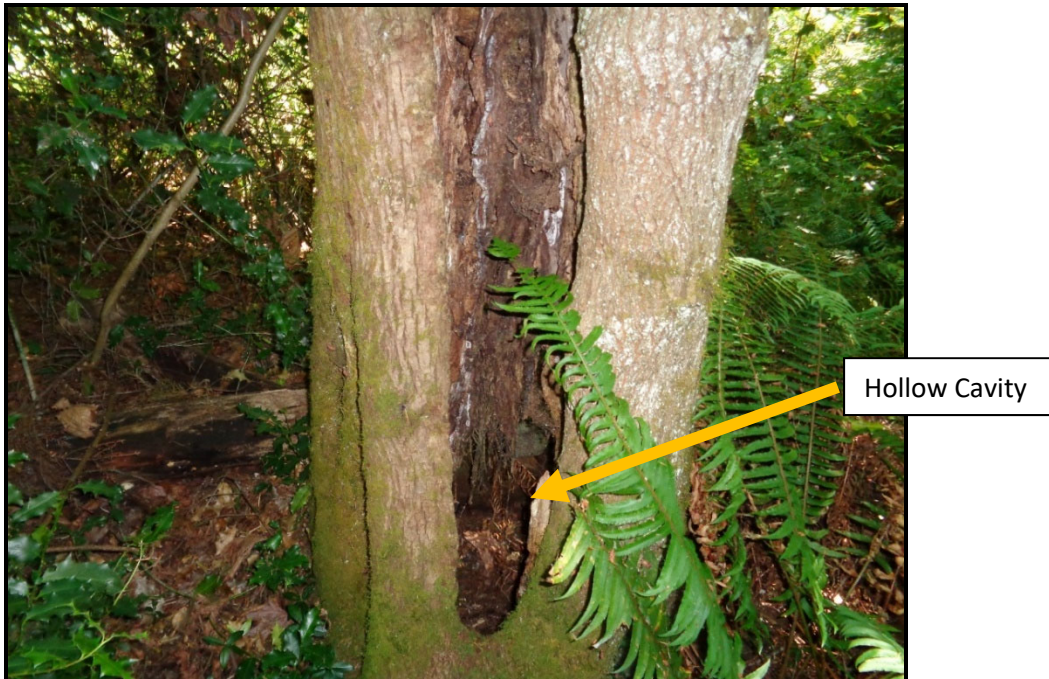
**Photo 1:** Some of the bigleaf maples (*Acer macrophyllum*) growing in the natural area had large cavities due to a heart rot decay.

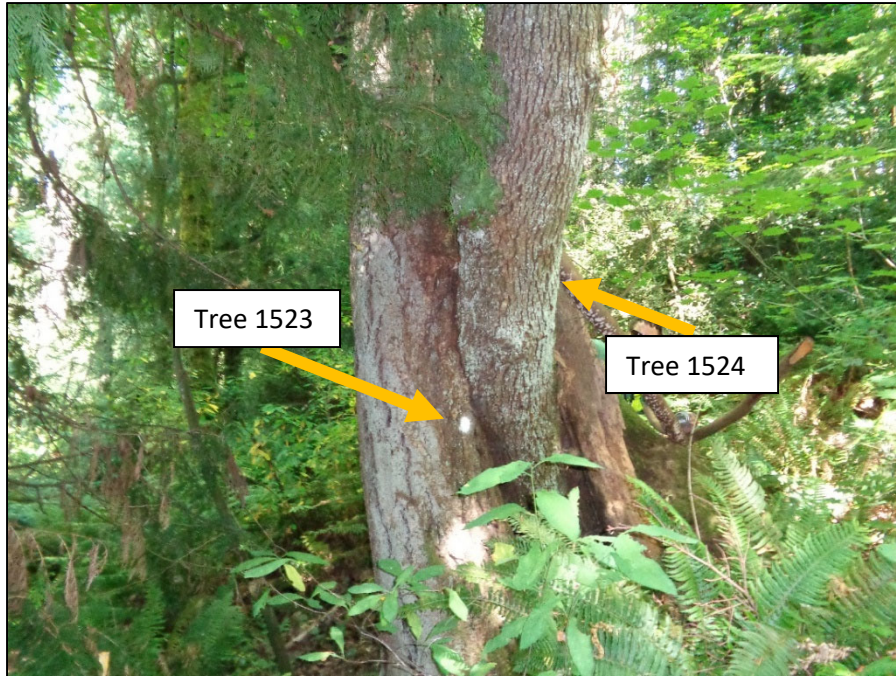
**Photo 3:** Tree 1524 growing around tree 1523. These trees were growing in the forested portion of the site.

1524	Site Tree	<i>Acer macrophyllum</i>	Bigleaf maple	20.8	Good	Fair	21	Significant	Retain	Viable		Growing around tree 1523
1525	Site Tree	<i>Thuja plicata</i>	Western redcedar	13.4	Good	Fair	8	Significant	Retain	Viable		Lost leader at 6 feet
1526	Site Tree	<i>Thuja plicata</i>	Western redcedar	9.2	Good	Good	7	Significant	Retain	Viable		
1527	Site Tree	<i>Acer macrophyllum</i>	Bigleaf maple	11.6	Good	Poor	14	Significant	Retain - Unhealthy	Non-Viable		Failure at base, uncorrected lean north approximately 30 degrees, only live growth is epicormic shoots on trunk
1528	Site Tree	<i>Acer macrophyllum</i>	Bigleaf maple	18.2	Good	Good	13	Significant	Retain	Viable		
1529	Site Tree	<i>Acer macrophyllum</i>	Bigleaf maple	16.6	Good	Fair	11	Significant	Retain	Viable		Some basal decay
1530	Site Tree	<i>Thuja plicata</i>	Western redcedar	9.6	Good	Good	9	Significant	Retain	Viable		
1531	Site Tree	<i>Thuja plicata</i>	Western redcedar	9.1	Good	Good	8	Significant	Retain	Viable
